NDL-TM-45

EFFECTS OF VEHICULAR OPERATION ON
CONTAMINATED SLUSHY ROADS

Joseph C. Maloney

July 1968

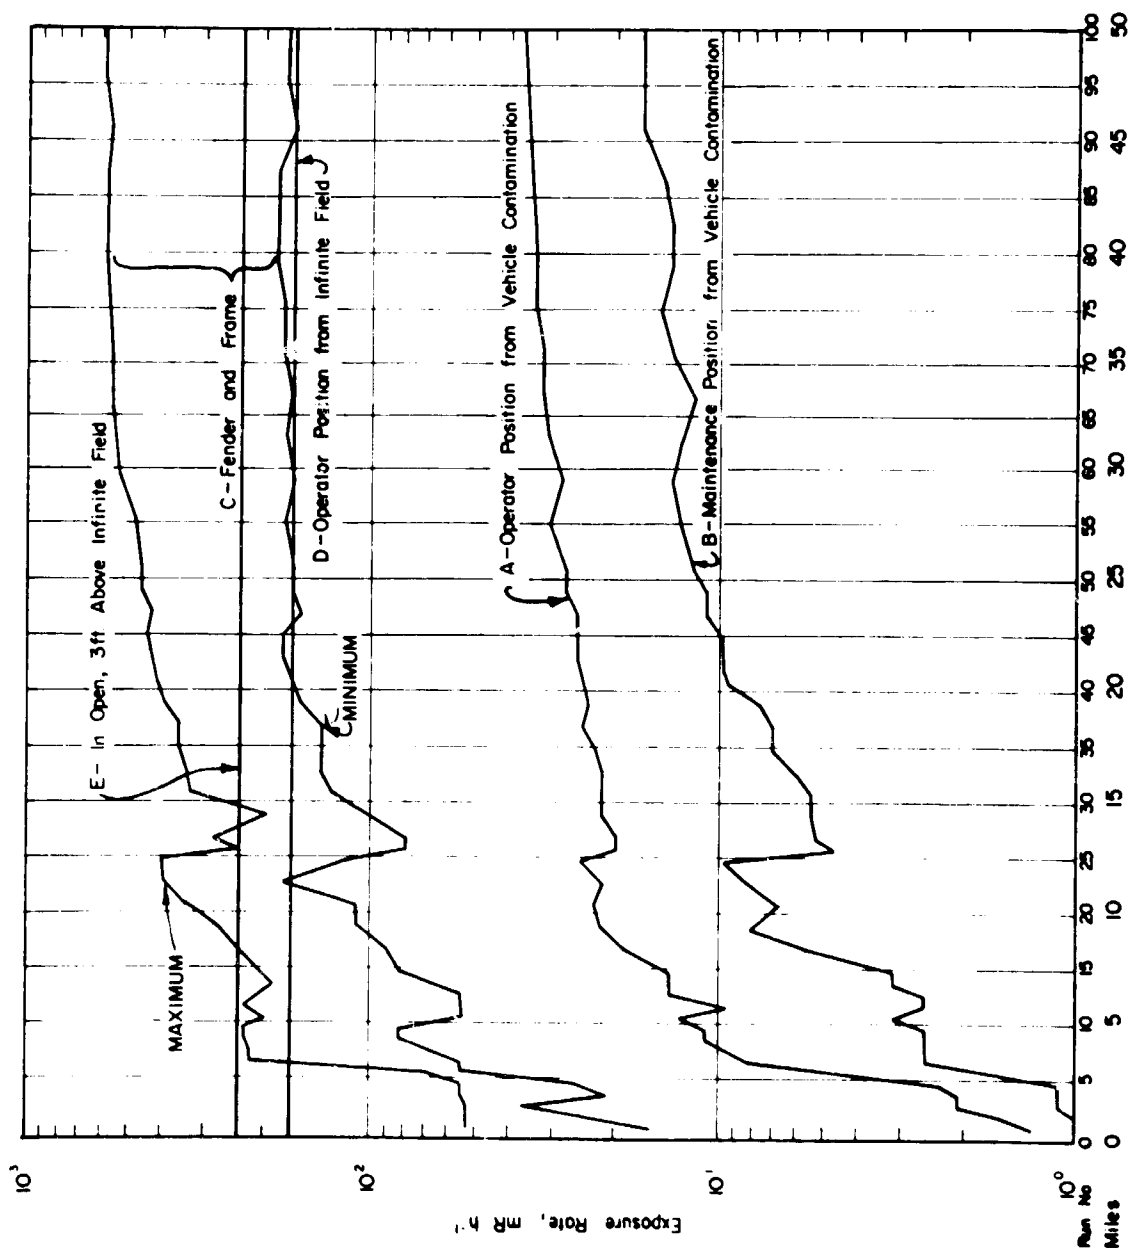
- A- Operator position, due to vehicle contamination.
- B- Maintenance position (over front of hood), due to vehicle contamination.
- C- Contamination levels at fenders and frame due to vehicle contamination.

Figure 3.3 Exposure rates for Test No. 1 normalized to 1 mCi ft⁻² contamination level.

D- Operator position from infinite radiation field
(Reference 1).

E- Open field at three-foot height (Reference 1).

Table A.1 in the Appendix contains exposure rates due to contamination of the vehicle at several vehicle locations for Test No. 1. Table A.2 contains the exposure rates for Test No. 2. These exposure rates have been normalized from experimental conditions to a road contamination level of 1 mCi ft^{-2} for direct comparison and are graphically presented in Figures 3.3 and 3.4. (Normalization of experimental data was based on data contained in Tables A.5 and A.6.) The following vehicle-location exposure rate data and other radiation exposure data of interest are presented in these figures:

Figures 3.3 and 3.4 show that after about 25 miles, the exposure rates from contamination on the jeep seemed to stabilize or only change slightly with time. Test No. 2 exposure rates were higher than those for Test No. 1, probably because the contaminant was more accessible to displacement by the vehicle tires. The operator exposure rate due to simulant being

retained on the vehicle was significant, particularly for Test No. 2 where it was always a significant fraction of the exposure rate expected from the surrounding infinite field. The exposure rates at the engine maintenance position were lower than those at the operator position but approached 10 percent of the unprotected open infinite field exposure. In any case, decontamination of the vehicle is indicated to be a requirement following operation on slush-covered roads.

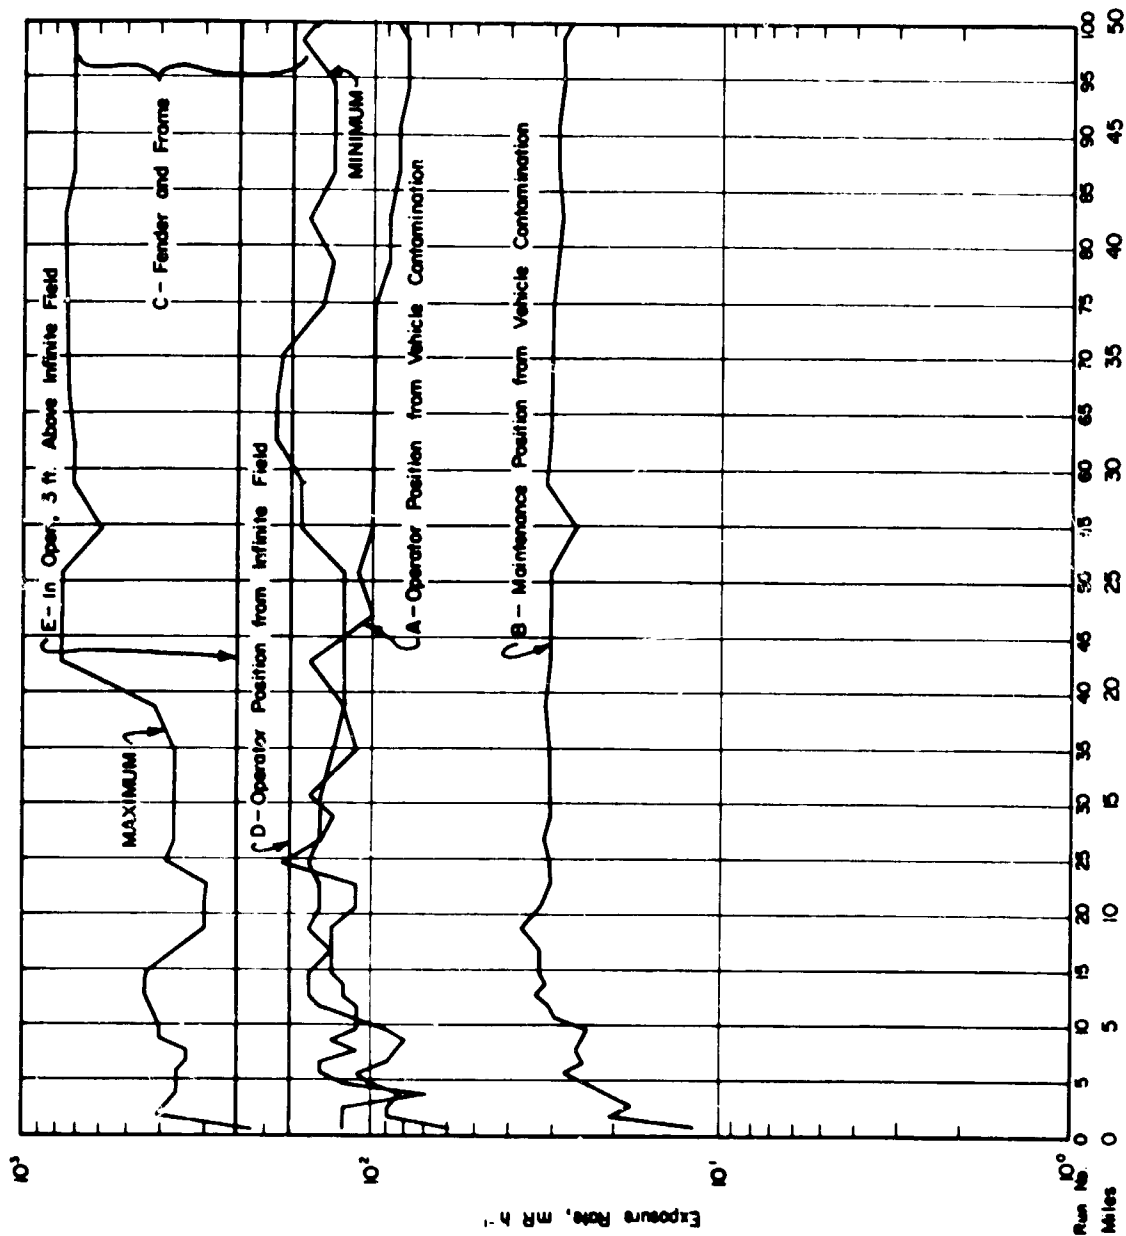
Figure 3.4 Exposure rates for Test No. 2 normalized to 1 mCi ft⁻² contamination level.
